1. **PRB: The HUMAC Reports Comfort Switch Pressed When It Was Not Pressed.**
2. **SYMPTOMS**
 - 2.1. The HUMAC reports Error 2001 (Comfort Switch Pressed) when the switch was not pressed.
3. **CAUSE**
 - 3.1. This can be caused by a faulty comfort switch.
 - 3.2. The resistance between the two outer tabs of the comfort switch should be near 0Ω when the switch is NOT pressed (Figure 1) and infinite (open) when the switch is pressed (Figure 2).

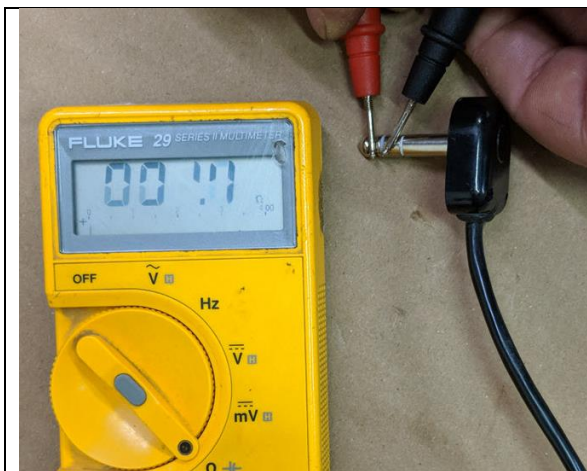
Figure 1 Switch not pressed.

4. **RESOLUTION**
 - 4.1. If the switch is not working correctly it should be replaced by CSMi.
5. **STATUS**
 - 5.1. The above steps resolve this problem.

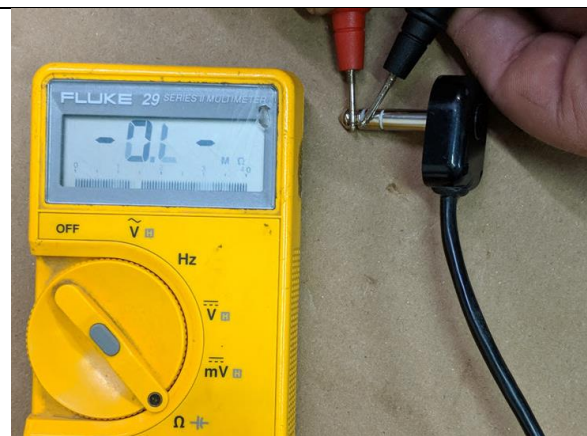
Figure 2 Switch Pressed
